B&N Coal, Inc., West Fork Surface Coal Remining Project

Remining Information Series

Case Study: B&N Coal, Inc. West Fork Project

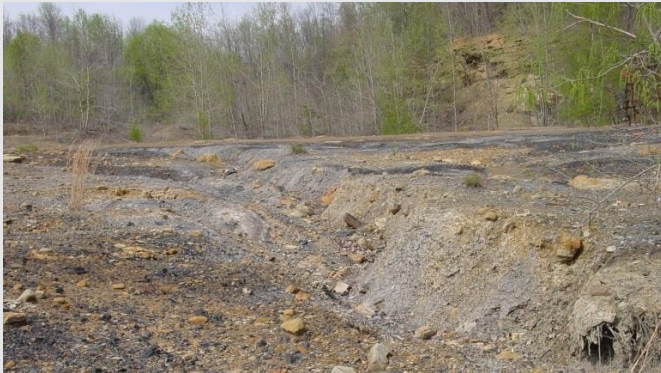
Exposed spoils are poorly vegetated and highly erosive.

The grey, toxic, acid-forming spoils that cover the pit floor are highly erosive, contributing to erosion gullies. Vegetation is sparse due to the toxic nature of the spoils. Water that comes into contact with the spoil becomes acidic, forming acid mine drainage (AMD). AMD from the unreclaimed mine areas forms the headwaters of the streams that flow from the project area. During remining, exposed coal auger areas are removed; the highwalls and pits are backfilled and the spoils are graded, topsoiled, and revegetated. Through remining and reclamation of the AML, water quality on site and off site is improved.

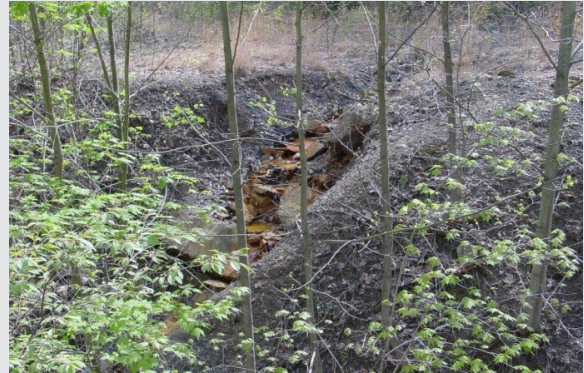
Erosion in spoil forms headwater of stream.

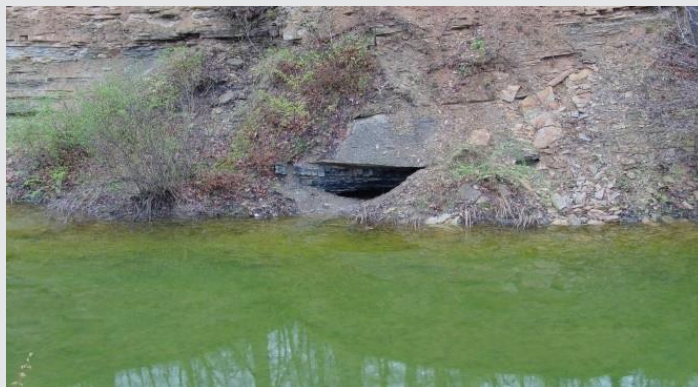
An auger hole is exposed along the highwall.

Water Quality Impacts: The majority of the pit ponds and seeps within the project area are acidic with pH values less than 4.0. S.U. is common. The severe acidity is due to exposure of water to acidic spoils, the exposed coal seam, auger holes, and deep mine voids. Auger holes and deep mine voids worsen AMD formation resulting in highly acidic pit ponds.

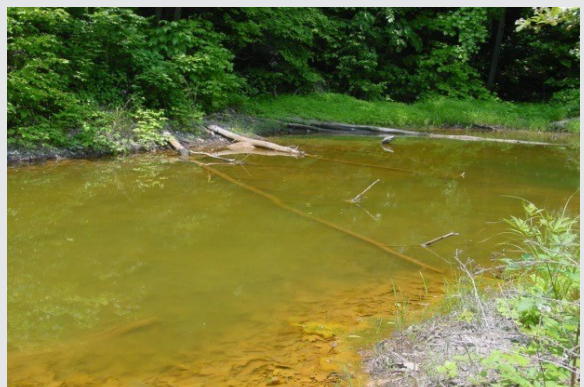
Poor water quality exhibited by orange staining.

The AMD formed within the West Fork Project provides the headwater source for the streams flowing from the project area. It is estimated that approximately 6.5 miles of unnamed primary headwater tributary streams are impacted by acid mine drainage originating in the West Fork project area. The headwater tributaries downstream of the project exhibit the orange staining indicative of acid mine drainage and are filled with sediment, which degrades aquatic habitat.

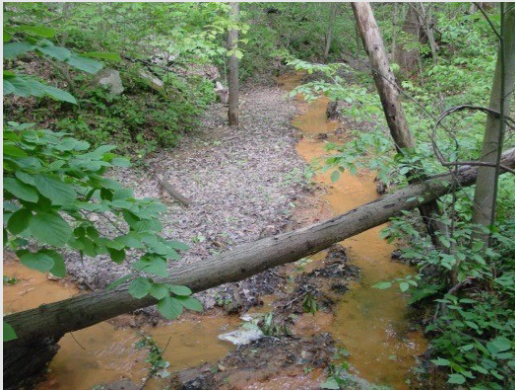
Headwater stream affected by acid mine drainage.

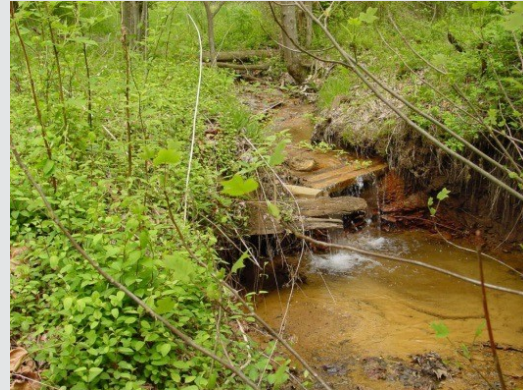
Poor water quality exhibited by orange staining.

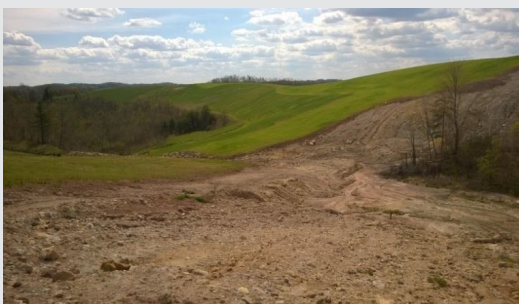
Fork reclamation.

Remining Progress: To date, approximately 100 acres of the project are completely remined and reclaimed and 39 acres have been remined and are under various stages of reclamation. Four permanent ponds have been constructed for the original permit and eight temporary ponds are planned for the adjacent area.

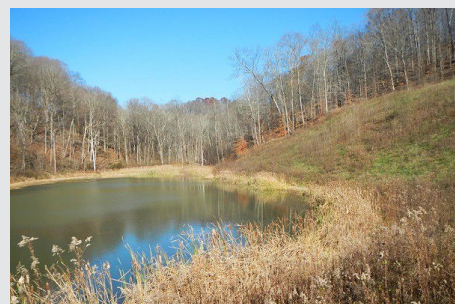
Permanent pond 002.

Permanent ponds constructed as sediment control for the remining project, like Pond 002 shown above, provide water quality improvement within weeks of construction. Over the long-term, ponds increase aquatic resource diversity on site and function as finishing ponds, adding to improved water quality upon completion of the remining project.

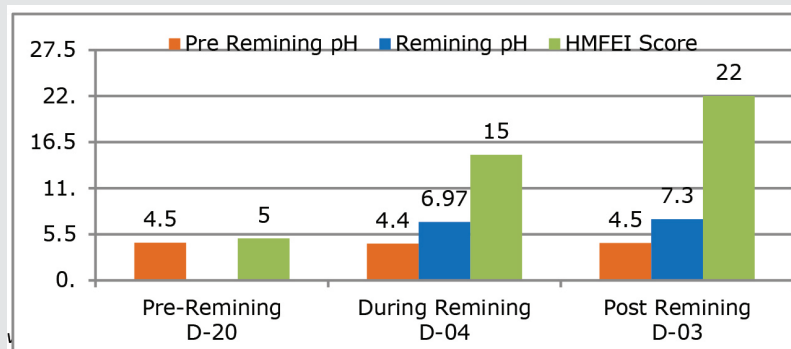
Water quality improvements are demonstrated by the increase in pH and the increase in the HMFEI biological assessment.

Water Quality Improvement: With the reclamation of the headwater of one watershed complete and the partial completion of a second, water quality improvement is observed. A total of 4.1 miles of stream have pH values greater than 7.0 S.U. and reduced concentrations of minerals, such as iron, manganese, and aluminum. Biological attributes are improving in the streams as demonstrated by HMFEI biological assessment scores greater in those watersheds where reclamation is complete or in progress.

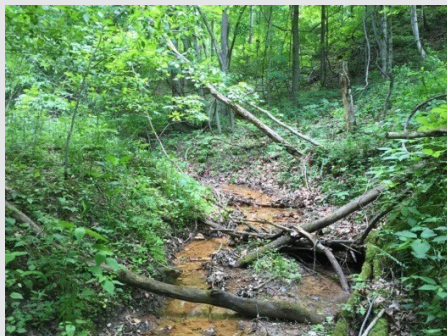
Monitoring Station D-20 not remined.

Monitored stream segment D-20 has an extremely poor habitat and the remining pH averages 4.5 S.U. The stream is stained orange by AMD and sediment impacts habitat quality. The remining project has not moved into this watershed. The HMFEI score of 5 reflects the poor quality of the stream. Monitored stream segment D-04 is downstream of permanent pond 004. Active mining was taking place in the watershed during the HMFEI biological assessment. The average during remining pH at this study segment is 6.97 S.U. and sediment is being flushed from the stream. The HMFEI biological assessment score is 15, demonstrating that the stream is in the process of recovery. The HMFEI score is anticipated to continue to improve with the completion of the remining project.

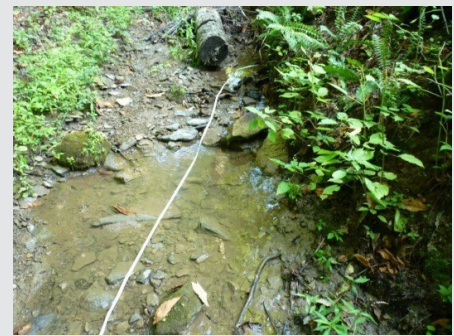
Monitoring Station D-03.

The monitored stream segment D-03 is downstream of permanent ponds 001 and 002. Mining has been completed in this watershed with the majority of the watershed under reclamation. The stream is in recovery. The average pH at this site is 7.3 S.U. and sediment has been flushed from the system. The HMFEI biological assessment score is 22 reflecting the improvement in water quality. It is anticipated that the biological community will continue to improve with time.
